Compliance Evaluation Report

หมายเลขรายงาน: CSSC/BOS/003

PV grid-connected inverter

X1-MINI-3.0K-G4

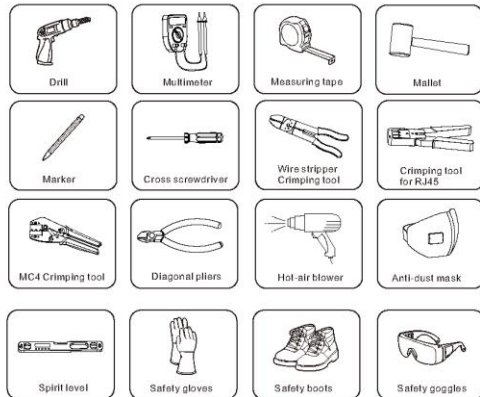
Tools below are needed before installation.

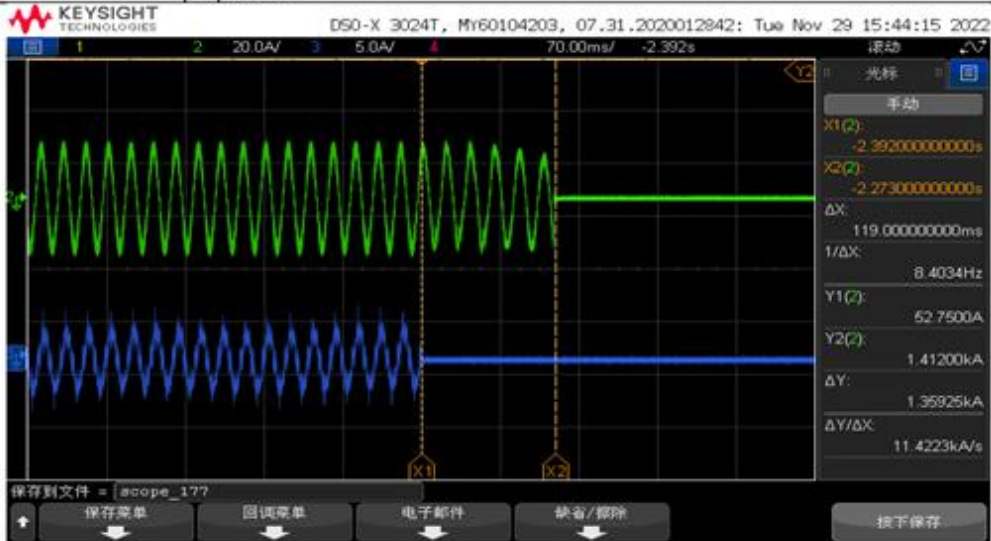
Picture No.:	31	Clause:	4.3.6
Test:	<input checked="" type="checkbox"/> Islanding Protection <input type="checkbox"/> Secondary Over Voltage Magnitude <input type="checkbox"/> Secondary Over Voltage Trip Time <input type="checkbox"/> Secondary Under Voltage Magnitude <input type="checkbox"/> Secondary Under Voltage Trip Time <input type="checkbox"/> Under Frequency Magnitude <input type="checkbox"/> Under Frequency Trip Time	<input type="checkbox"/> First Over Voltage Magnitude <input type="checkbox"/> First Over Voltage Trip Time <input type="checkbox"/> First Under Voltage Magnitude <input type="checkbox"/> First Under Voltage Trip Time <input type="checkbox"/> Over Frequency Magnitude <input type="checkbox"/> Over Frequency Trip Time <input type="checkbox"/> Response to Utility Recovery	
Test description:	100% load, PR: -10%, QC: +10%, the trip time of protection was 119.0ms. CH1 were the output currents of the inverter; CH2 were the currents flowing through to the grid, also regarded as the trip signal while the grid was switched off. The wave No. was ordered from top to end.

2.6 การทดสอบการป้องกันสภาวะไอส์แลนด์ (Islanding Protection)									
Item	Test Condition C			Test Condition B			Test Condition A		
	P _{AC} (% of nominal)	Q _{AC} (% of nominal)	Run on Time (sec) (Limit ≤2 Sec)	P _{AC} (% of nominal)	Q _{AC} (% of nominal)	Run on Time (sec) (Limit ≤2 Sec)	P _{AC} (% of nominal)	Q _{AC} (% of nominal)	Run on Time (sec) (Limit ≤2 Sec)
1	0	0	<u>0.425</u>	0	0	<u>0.920</u>	0	0	0.262
2	0	-5	0.150	0	-5	0.074	-10	-10	0.100
3	0	-4	0.168	0	-4	0.120	-10	-5	0.120
4	0	-3	0.386	0	-3	0.206	-10	0	0.314
5	0	-2	0.375	0	-2	0.378	-10	+5	0.250
6	0	-1	0.340	0	-1	0.392	-10	+10	0.119
7	0	1	0.260	0	1	0.250	-5	-10	0.093
8	0	2	0.240	0	2	0.216	-5	-5	0.135
9	0	3	0.150	0	3	0.244	-5	0	<u>0.660</u>
10	0	4	0.216	0	4	0.330	-5	+5	0.310
11	0	5	0.084	0	5	0.234	-5	+10	0.101
12							0	-10	0.085
13							0	-5	0.106
14							0	+5	0.236
15							0	+10	0.120
16							+5	-10	0.088
17							+5	-5	0.114
18							+5	0	0.415

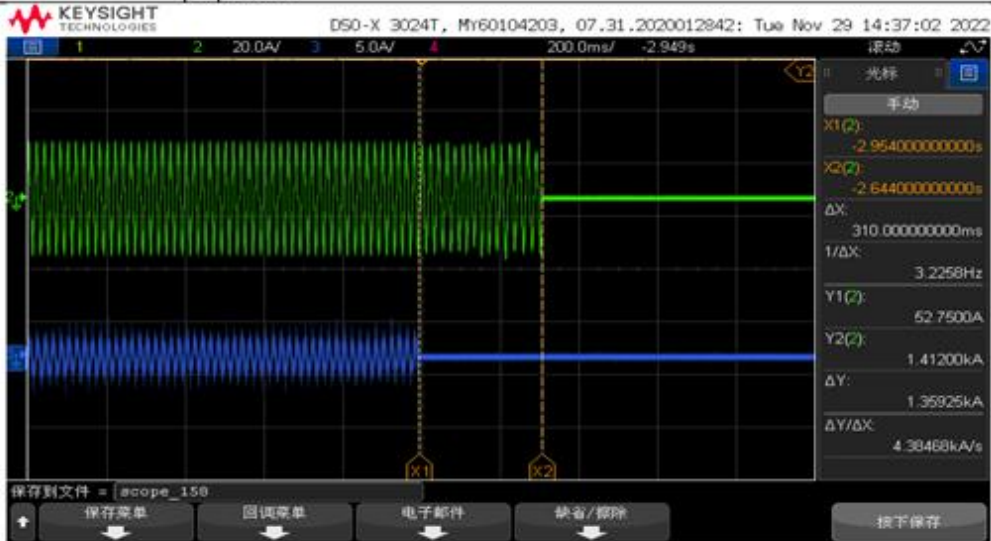
Picture No.:	39	Clause:	4.3.6
Test:	<input checked="" type="checkbox"/> Islanding Protection <input type="checkbox"/> Secondary Over Voltage Magnitude <input type="checkbox"/> Secondary Over Voltage Trip Time <input type="checkbox"/> Secondary Under Voltage Magnitude <input type="checkbox"/> Secondary Under Voltage Trip Time <input type="checkbox"/> Under Frequency Magnitude <input type="checkbox"/> Under Frequency Trip Time	<input type="checkbox"/> First Over Voltage Magnitude <input type="checkbox"/> First Over Voltage Trip Time <input type="checkbox"/> First Under Voltage Magnitude <input type="checkbox"/> First Under Voltage Trip Time <input type="checkbox"/> Over Frequency Magnitude <input type="checkbox"/> Over Frequency Trip Time <input type="checkbox"/> Response to Utility Recovery	
Test description:	100% load, PR: -5%, QC: +5%, the trip time of protection was 310.0ms. CH1 were the output currents of the inverter; CH2 were the currents flowing through to the grid, also regarded as the trip signal while the grid was switched off. The wave No. was ordered from top to end.

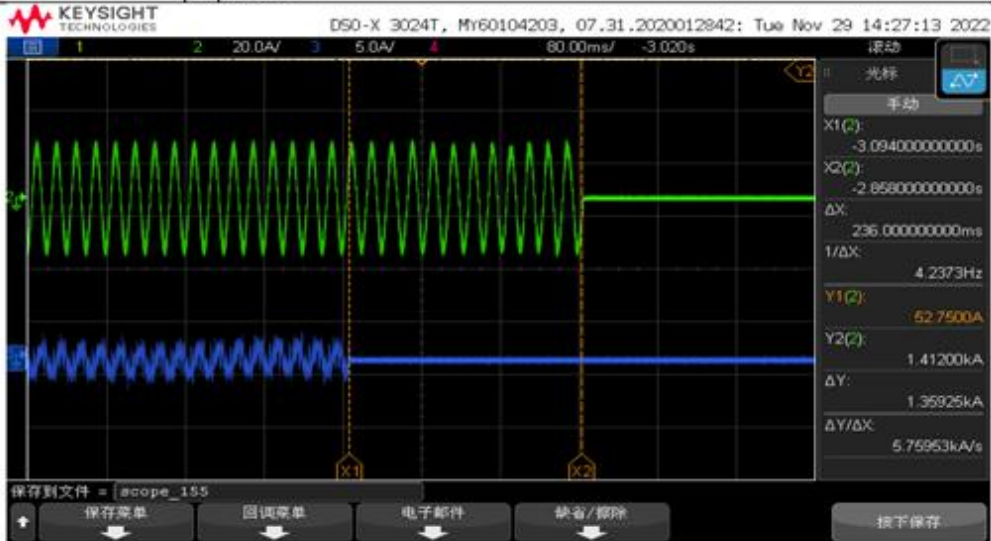
Picture No.:	42	Clause:	4.3.6
Test:	<input checked="" type="checkbox"/> Islanding Protection <input type="checkbox"/> Secondary Over Voltage Magnitude <input type="checkbox"/> Secondary Over Voltage Trip Time <input type="checkbox"/> Secondary Under Voltage Magnitude <input type="checkbox"/> Secondary Under Voltage Trip Time <input type="checkbox"/> Under Frequency Magnitude <input type="checkbox"/> Under Frequency Trip Time	<input type="checkbox"/> First Over Voltage Magnitude <input type="checkbox"/> First Over Voltage Trip Time <input type="checkbox"/> First Under Voltage Magnitude <input type="checkbox"/> First Under Voltage Trip Time <input type="checkbox"/> Over Frequency Magnitude <input type="checkbox"/> Over Frequency Trip Time <input type="checkbox"/> Response to Utility Recovery	
Test description:	100% load, PR: 0%, QC: +5%, the trip time of protection was 236.0ms. CH1 were the output currents of the inverter; CH2 were the currents flowing through to the grid, also regarded as the trip signal while the grid was switched off. The wave No. was ordered from top to end.

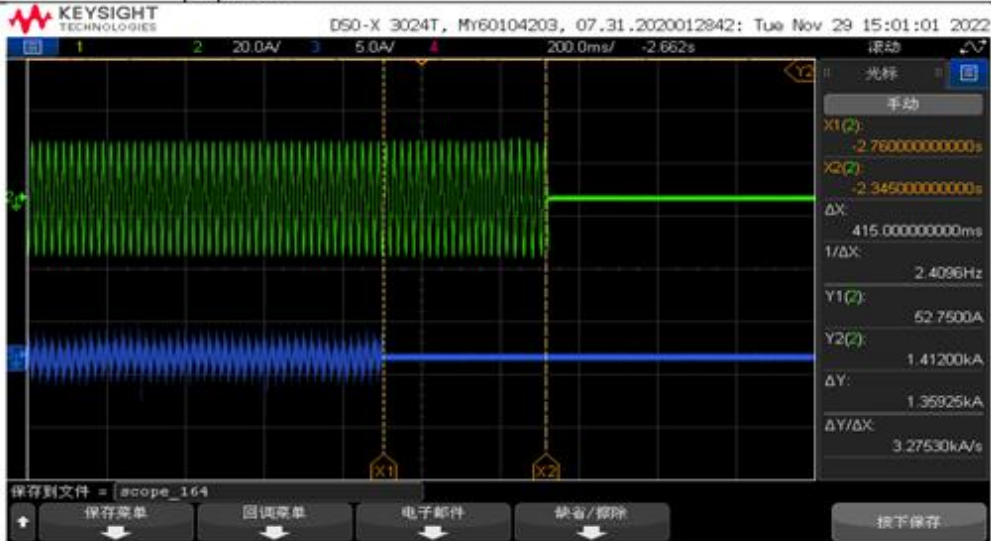
Picture No.:	47	Clause:	4.3.6
Test:	<input checked="" type="checkbox"/> Islanding Protection <input type="checkbox"/> Secondary Over Voltage Magnitude <input type="checkbox"/> Secondary Over Voltage Trip Time <input type="checkbox"/> Secondary Under Voltage Magnitude <input type="checkbox"/> Secondary Under Voltage Trip Time <input type="checkbox"/> Under Frequency Magnitude <input type="checkbox"/> Under Frequency Trip Time	<input type="checkbox"/> First Over Voltage Magnitude <input type="checkbox"/> First Over Voltage Trip Time <input type="checkbox"/> First Under Voltage Magnitude <input type="checkbox"/> First Under Voltage Trip Time <input type="checkbox"/> Over Frequency Magnitude <input type="checkbox"/> Over Frequency Trip Time <input type="checkbox"/> Response to Utility Recovery	
Test description:	100% load, PR: +5%, QC: 0%, the trip time of protection was 415.0ms. CH1 were the output currents of the inverter; CH2 were the currents flowing through to the grid, also regarded as the trip signal while the grid was switched off. The wave No. was ordered from top to end.

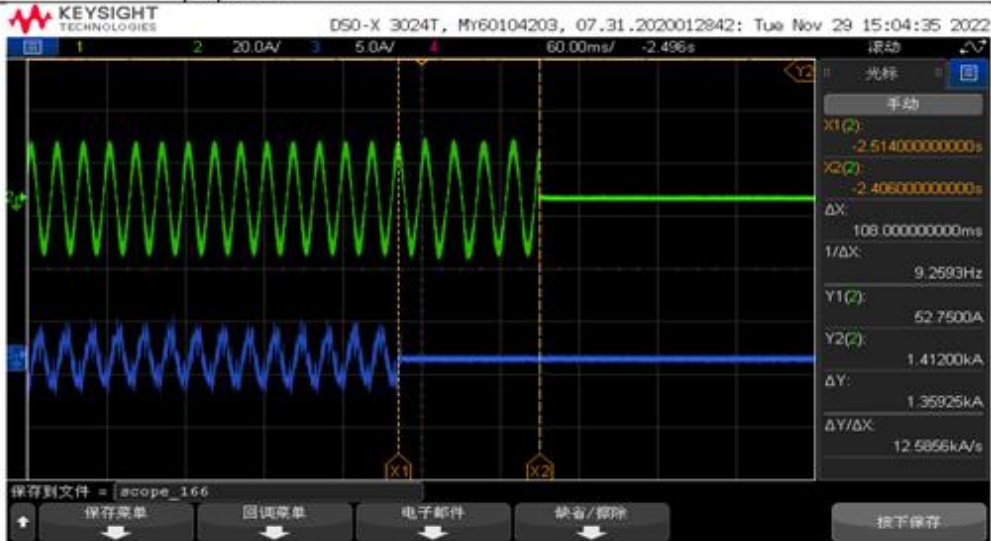
Picture No.:	50	Clause:	4.3.6
Test:	<input checked="" type="checkbox"/> Islanding Protection <input type="checkbox"/> Secondary Over Voltage Magnitude <input type="checkbox"/> Secondary Over Voltage Trip Time <input type="checkbox"/> Secondary Under Voltage Magnitude <input type="checkbox"/> Secondary Under Voltage Trip Time <input type="checkbox"/> Under Frequency Magnitude <input type="checkbox"/> Under Frequency Trip Time	<input type="checkbox"/> First Over Voltage Magnitude <input type="checkbox"/> First Over Voltage Trip Time <input type="checkbox"/> First Under Voltage Magnitude <input type="checkbox"/> First Under Voltage Trip Time <input type="checkbox"/> Over Frequency Magnitude <input type="checkbox"/> Over Frequency Trip Time <input type="checkbox"/> Response to Utility Recovery	
Test description:	100% load, PR: +5%, QC: +10%, the trip time of protection was 108.0ms. CH1 were the output currents of the inverter; CH2 were the currents flowing through to the grid, also regarded as the trip signal while the grid was switched off. The wave No. was ordered from top to end.

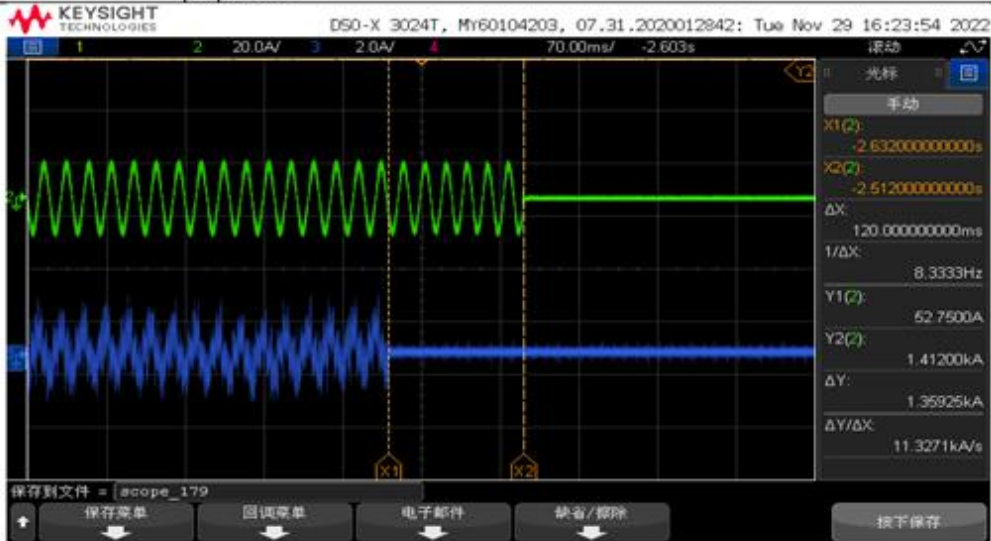
Picture No.:	58	Clause:	4.3.6
Test:	<input checked="" type="checkbox"/> Islanding Protection <input type="checkbox"/> Secondary Over Voltage Magnitude <input type="checkbox"/> Secondary Over Voltage Trip Time <input type="checkbox"/> Secondary Under Voltage Magnitude <input type="checkbox"/> Secondary Under Voltage Trip Time <input type="checkbox"/> Under Frequency Magnitude <input type="checkbox"/> Under Frequency Trip Time	<input type="checkbox"/> First Over Voltage Magnitude <input type="checkbox"/> First Over Voltage Trip Time <input type="checkbox"/> First Under Voltage Magnitude <input type="checkbox"/> First Under Voltage Trip Time <input type="checkbox"/> Over Frequency Magnitude <input type="checkbox"/> Over Frequency Trip Time <input type="checkbox"/> Response to Utility Recovery	
Test description:	66% load, PR: 0%, QC: -4%, the trip time of protection was 120.0ms. CH1 were the output currents of the inverter; CH2 were the currents flowing through to the grid, also regarded as the trip signal while the grid was switched off. The wave No. was ordered from top to end.

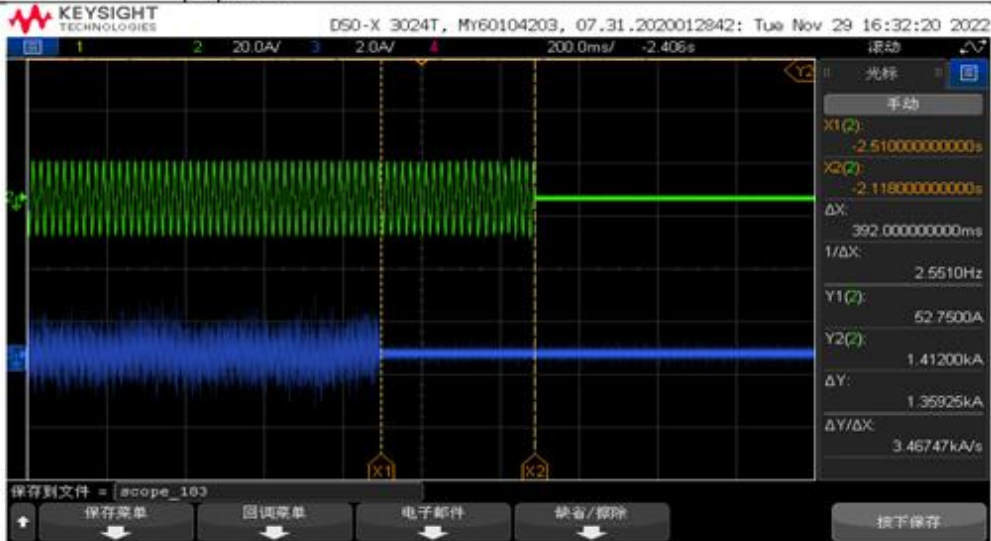
Picture No.:	61	Clause:	4.3.6
Test:	<input checked="" type="checkbox"/> Islanding Protection <input type="checkbox"/> Secondary Over Voltage Magnitude <input type="checkbox"/> Secondary Over Voltage Trip Time <input type="checkbox"/> Secondary Under Voltage Magnitude <input type="checkbox"/> Secondary Under Voltage Trip Time <input type="checkbox"/> Under Frequency Magnitude <input type="checkbox"/> Under Frequency Trip Time		<input type="checkbox"/> First Over Voltage Magnitude <input type="checkbox"/> First Over Voltage Trip Time <input type="checkbox"/> First Under Voltage Magnitude <input type="checkbox"/> First Under Voltage Trip Time <input type="checkbox"/> Over Frequency Magnitude <input type="checkbox"/> Over Frequency Trip Time <input type="checkbox"/> Response to Utility Recovery
Test description:	66% load, PR: 0%, QC: -1%, the trip time of protection was 392.0ms. CH1 were the output currents of the inverter; CH2 were the currents flowing through to the grid, also regarded as the trip signal while the grid was switched off. The wave No. was ordered from top to end.

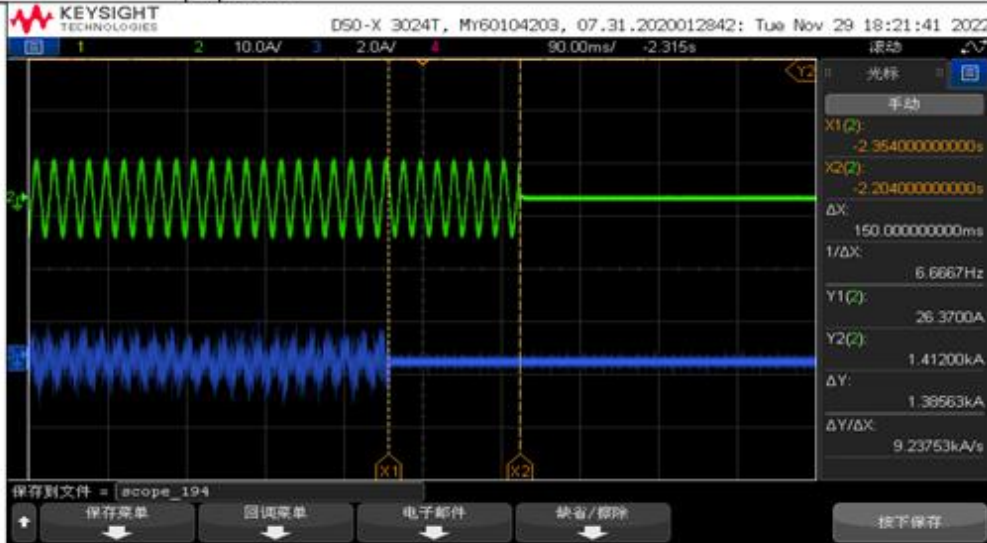
Picture No.:	69	Clause:	4.3.6
Test:	<input checked="" type="checkbox"/> Islanding Protection <input type="checkbox"/> Secondary Over Voltage Magnitude <input type="checkbox"/> Secondary Over Voltage Trip Time <input type="checkbox"/> Secondary Under Voltage Magnitude <input type="checkbox"/> Secondary Under Voltage Trip Time <input type="checkbox"/> Under Frequency Magnitude <input type="checkbox"/> Under Frequency Trip Time	<input type="checkbox"/> First Over Voltage Magnitude <input type="checkbox"/> First Over Voltage Trip Time <input type="checkbox"/> First Under Voltage Magnitude <input type="checkbox"/> First Under Voltage Trip Time <input type="checkbox"/> Over Frequency Magnitude <input type="checkbox"/> Over Frequency Trip Time <input type="checkbox"/> Response to Utility Recovery	
Test description:	33% load, PR: 0%, QC: -5%, the trip time of protection was 150.0ms. CH1 were the output currents of the inverter; CH2 were the currents flowing through to the grid, also regarded as the trip signal while the grid was switched off. The wave No. was ordered from top to end.

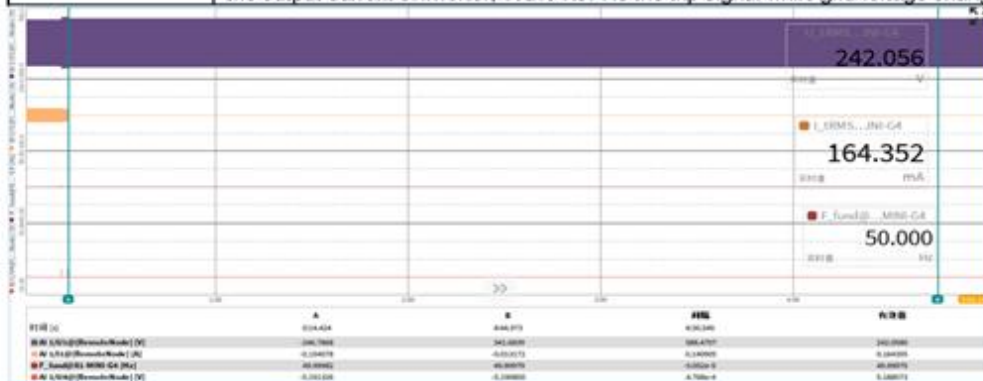
Picture No.:	81	Clause:	4.3.7
Test:	<input type="checkbox"/> Islanding Protection <input type="checkbox"/> Secondary Over Voltage Magnitude <input type="checkbox"/> Secondary Over Voltage Trip Time <input type="checkbox"/> Secondary Under Voltage Magnitude <input type="checkbox"/> Secondary Under Voltage Trip Time <input type="checkbox"/> Under Frequency Magnitude <input type="checkbox"/> Under Frequency Trip Time		<input type="checkbox"/> First Over Voltage Magnitude <input type="checkbox"/> First Over Voltage Trip Time <input type="checkbox"/> First Under Voltage Magnitude <input type="checkbox"/> First Under Voltage Trip Time <input type="checkbox"/> Over Frequency Magnitude <input type="checkbox"/> Over Frequency Trip Time <input checked="" type="checkbox"/> Response to Utility Recovery
Test description:	Inverter won't reconnect to grid while the grid voltage remained over 240V after the first level over voltage protection was tripped; Wave No. 1 is the grid voltage; Wave No. 2 is the output current of inverter; Wave No. 4 is the trip signal while grid voltage changed.

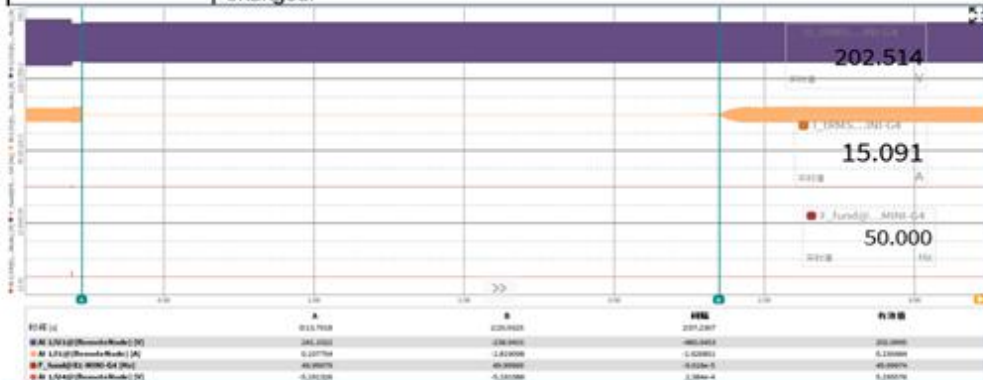
Picture No.:	84	Clause:	4.3.7
Test:	<input type="checkbox"/> Islanding Protection <input type="checkbox"/> Secondary Over Voltage Magnitude <input type="checkbox"/> Secondary Over Voltage Trip Time <input type="checkbox"/> Secondary Under Voltage Magnitude <input type="checkbox"/> Secondary Under Voltage Trip Time <input type="checkbox"/> Under Frequency Magnitude <input type="checkbox"/> Under Frequency Trip Time		<input type="checkbox"/> First Over Voltage Magnitude <input type="checkbox"/> First Over Voltage Trip Time <input type="checkbox"/> First Under Voltage Magnitude <input type="checkbox"/> First Under Voltage Trip Time <input type="checkbox"/> Over Frequency Magnitude <input type="checkbox"/> Over Frequency Trip Time <input checked="" type="checkbox"/> Response to Utility Recovery
Test description:	Inverter reconnect to grid with 127.2s delay while grid voltage remained above 200V after the first level under voltage protection was tripped; Wave No. 1 is the grid voltage; Wave No. 3 is the output current of inverter; Wave No. 4 is the trip signal while grid voltage changed.

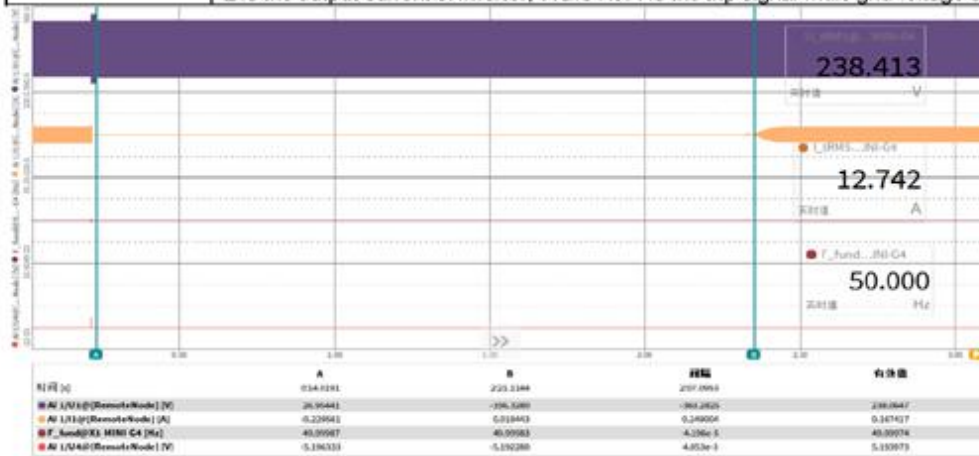
Picture No.:	90	Clause:	4.3.7
Test:	<input type="checkbox"/> Islanding Protection <input type="checkbox"/> Secondary Over Voltage Magnitude <input type="checkbox"/> Secondary Over Voltage Trip Time <input type="checkbox"/> Secondary Under Voltage Magnitude <input type="checkbox"/> Secondary Under Voltage Trip Time <input type="checkbox"/> Under Frequency Magnitude <input type="checkbox"/> Under Frequency Trip Time		<input type="checkbox"/> First Over Voltage Magnitude <input type="checkbox"/> First Over Voltage Trip Time <input type="checkbox"/> First Under Voltage Magnitude <input type="checkbox"/> First Under Voltage Trip Time <input type="checkbox"/> Over Frequency Magnitude <input type="checkbox"/> Over Frequency Trip Time <input checked="" type="checkbox"/> Response to Utility Recovery
Test description:	Inverter reconnect to grid with 127.1s delay while grid voltage remained below 240V after the level 2 over voltage protection was tripped; Wave No. 1 is the grid voltage; Wave No. 2 is the output current of inverter; Wave No. 4 is the trip signal while grid voltage changed.

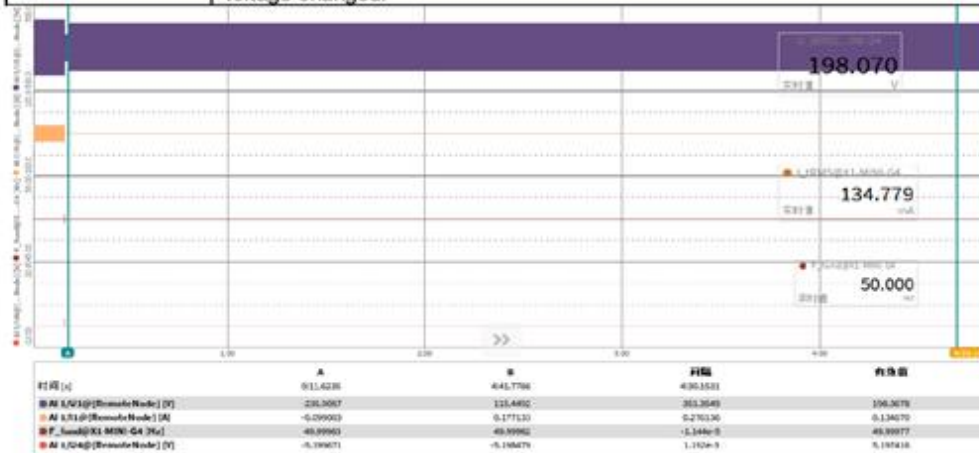
Picture No.:	91	Clause:	4.3.7
Test:	<input type="checkbox"/> Islanding Protection <input type="checkbox"/> Secondary Over Voltage Magnitude <input type="checkbox"/> Secondary Over Voltage Trip Time <input type="checkbox"/> Secondary Under Voltage Magnitude <input type="checkbox"/> Secondary Under Voltage Trip Time <input type="checkbox"/> Under Frequency Magnitude <input type="checkbox"/> Under Frequency Trip Time	<input type="checkbox"/> First Over Voltage Magnitude <input type="checkbox"/> First Over Voltage Trip Time <input type="checkbox"/> First Under Voltage Magnitude <input type="checkbox"/> First Under Voltage Trip Time <input type="checkbox"/> Over Frequency Magnitude <input type="checkbox"/> Over Frequency Trip Time <input checked="" type="checkbox"/> Response to Utility Recovery	
Test description:	Inverter won't reconnect to grid while the grid voltage remained under 200V after the second level 2 under voltage protection was tripped; Wave No. 1 is the grid voltage; Wave No. 2 is the output current of inverter; Wave No.4 is the trip signal while grid voltage changed.

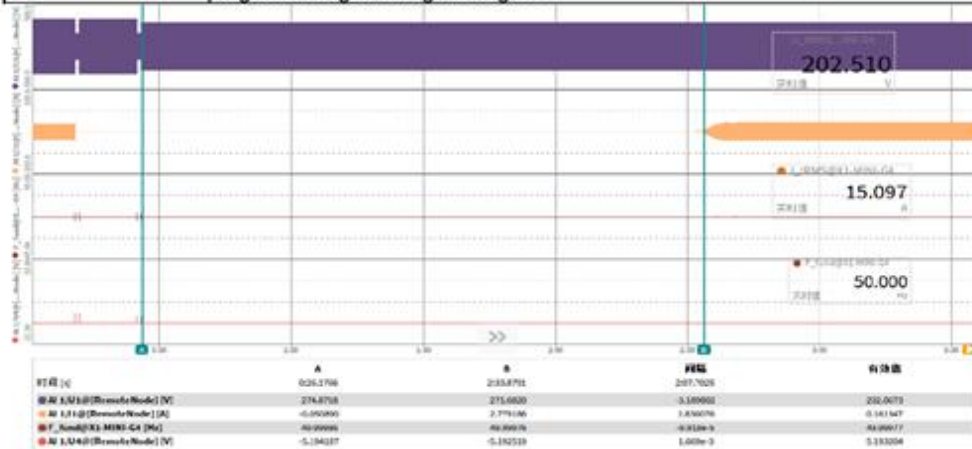
Picture No.:	98	Clause:	4.3.7
Test:	<input type="checkbox"/> Islanding Protection <input type="checkbox"/> Secondary Over Voltage Magnitude <input type="checkbox"/> Secondary Over Voltage Trip Time <input type="checkbox"/> Secondary Under Voltage Magnitude <input type="checkbox"/> Secondary Under Voltage Trip Time <input type="checkbox"/> Under Frequency Magnitude <input type="checkbox"/> Under Frequency Trip Time		<input type="checkbox"/> First Over Voltage Magnitude <input type="checkbox"/> First Over Voltage Trip Time <input type="checkbox"/> First Under Voltage Magnitude <input type="checkbox"/> First Under Voltage Trip Time <input type="checkbox"/> Over Frequency Magnitude <input type="checkbox"/> Over Frequency Trip Time <input checked="" type="checkbox"/> Response to Utility Recovery
Test description:	Inverter reconnect to grid with 127.7s delay while grid voltage remained above 200V. The grid voltage tripped under voltage level 2 again during the countdown period; Wave No.1 is the grid voltage; Wave No. 2 is the output current of inverter; Wave No.4 is the trip signal while grid voltage changed.
